Inventory of Green Spaces and Woody Plants in the Urban Landscape in Ariogala

Abstract

Materials and methods: An inventory of green spaces and woody plants was conducted in the public urban territory of Ariogala, using GIS technology. A digital cartographic database was created using ArcGIS 9.1 software.

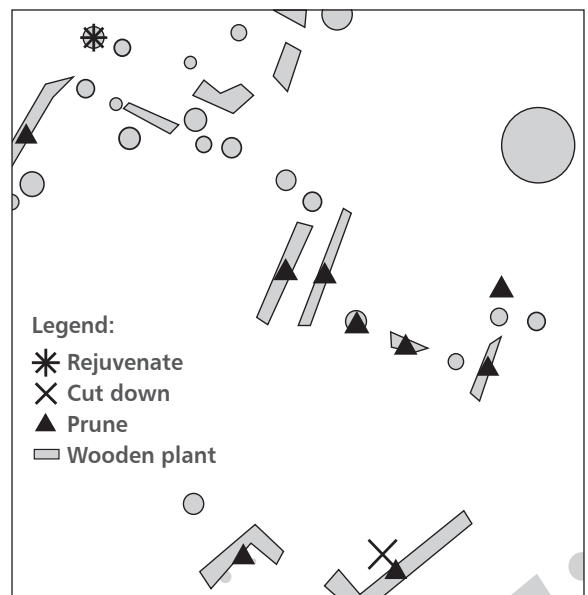
FIGURE 1
Woody plant management map

After plant condition was estimated and their possible negative impacts and aesthetic importance had been determined, the necessary management measures were planned (pruning, cutting down or removal of plants, rejuvenating shrubs, thinning, cutting deadwood) (Figure 1).

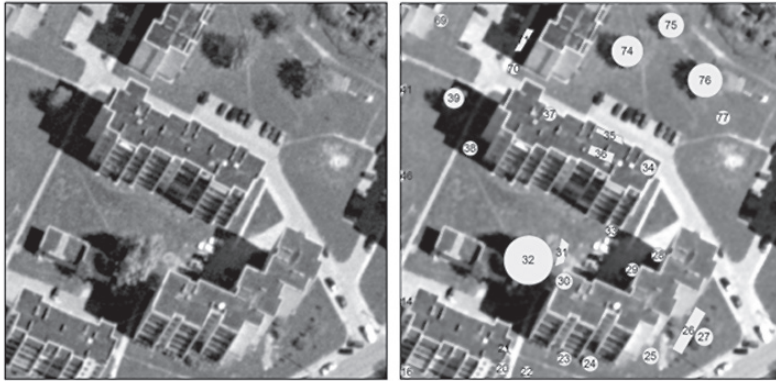
FIGURE 2
Creation of a woody plants layer

Cartographic material was prepared using ArcGIS 9.1 software. Aerial photographs at 1:2000 scale (in which all green spaces could be seen) were used. After collecting the necessary data for each plant, its location was noted in the photo, and it was given a number. Plant locations, including the canopy, were drawn in a polygon layer. In groups of plants where the canopies of the trees are touching and the location of individual trees could not be distinguished, the location of the entire group was noted. Data were submitted to the Lithuanian coordinate system LKS-94. For plants near tower blocks, location was estimated to scale, because building shadows can hide the plants (Figure 2).

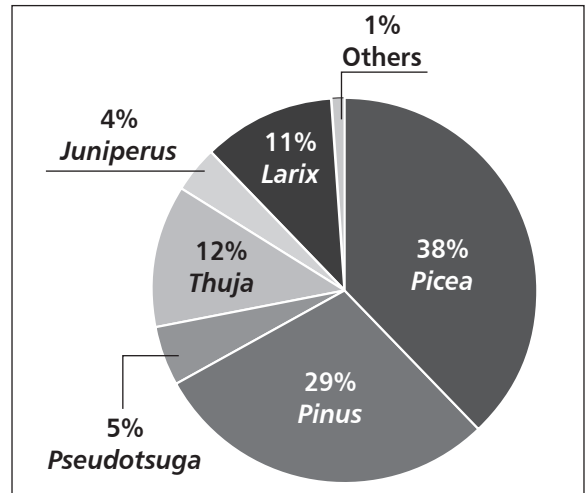
FIGURE 3
Composition of coniferous plants

The most common genus of conifers is *Picea*. Spruces account for 38% of the conifer population and pines account for 29% (Figure 3).

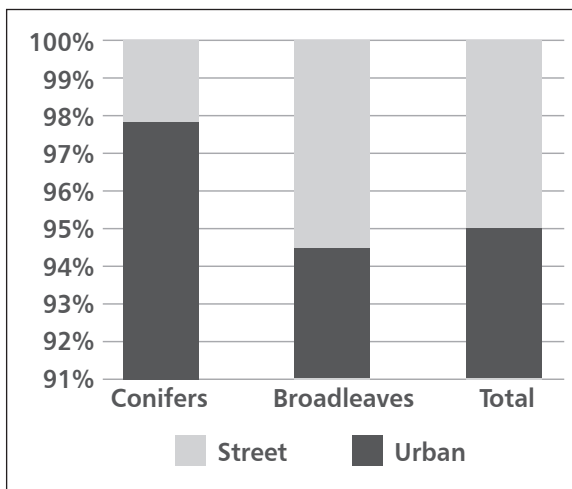
FIGURE 4
Distribution of conifers and broadleaves in different green spaces

The largest proportion of the woody plant population is composed of urban plants. In Ariogala, street trees comprise only about 5% of the city's woody plant population (Figure 4). Conifers comprise even less, only 2.2%. In Chicago, street trees comprise about 10% [9].

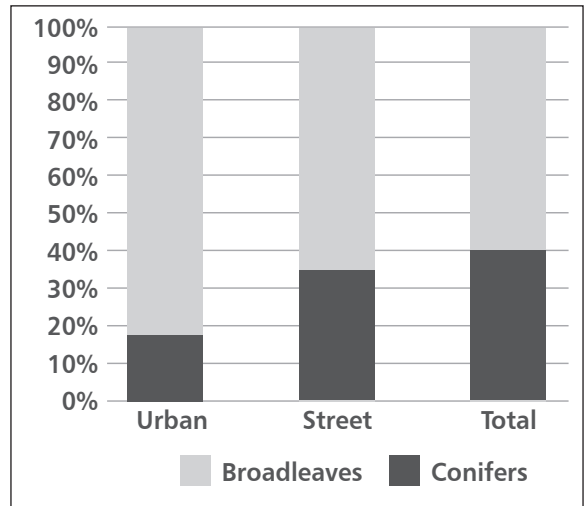
FIGURE 5
Distribution of urban and street woody plants by division

Broadleaves represent 84% of all woody plants in green spaces (Figure 5). Conifers are more common in urban green spaces than in street tree stands.

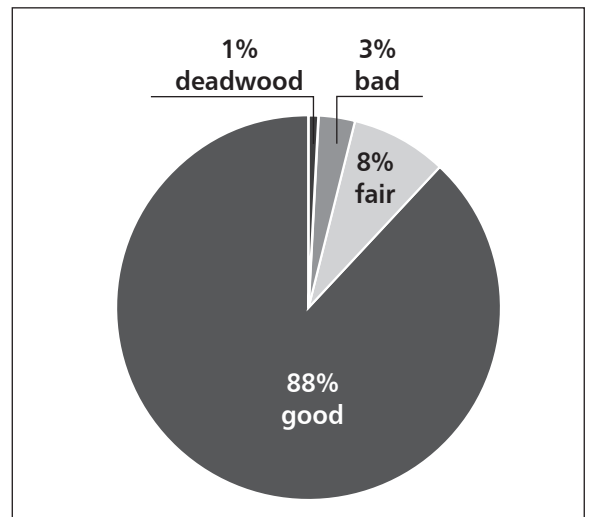
FIGURE 6
Distribution of woody plants by condition

Of the estimated 3436 individual woody plants and 397 groups in Ariogala, 88% are in good or excellent condition (Figure 6).

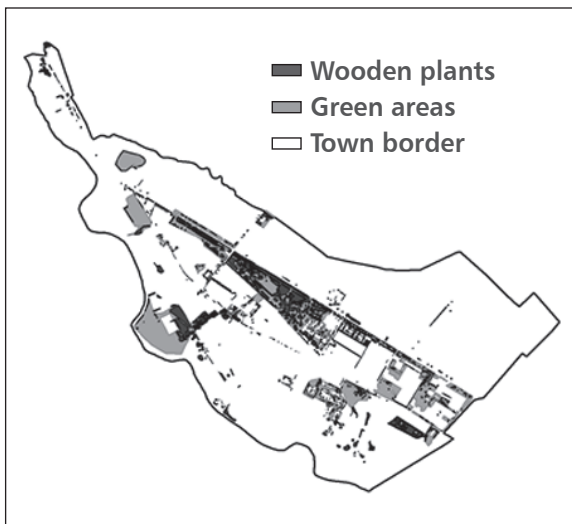
FIGURE 7
Green space and woody plant cover in Ariogala

Using aerial photographs, we created a layer that notes all territories and the town green space, in which individual plants and groups of plants growing in the canopy could be hidden (Figure 7).

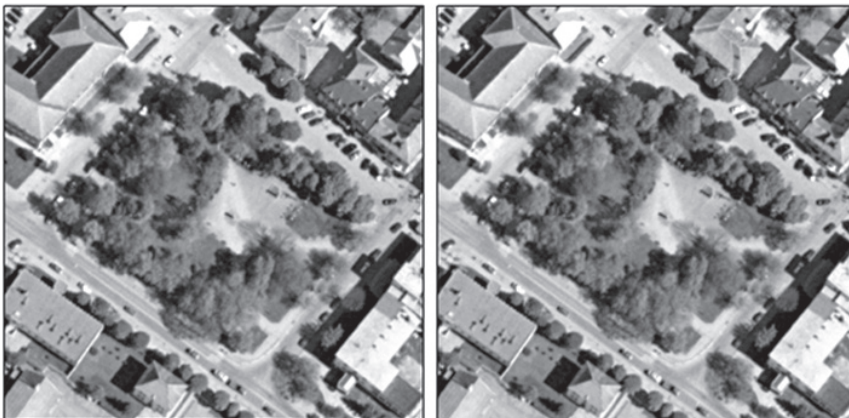
FIGURE 8
Visible square boundaries (left) and non-visible boundaries (right) of housing block sites.

During the tree inventory, the easiest way to distinguish the boundaries of city parks, squares and cemeteries was found. These boundaries are easily seen in aerial photography, often framed with roads, sidewalks and fences. Other green space boundaries cannot visually be distinguished accurately if the area is not fenced. It is extremely difficult to determine even the preliminary

green space boundaries in community areas composed of blocks of flats. Due to the absence of a layer showing planted trees during the inventory process, visual determination of the boundaries caused many errors, and the boundaries could not be identified if the planted territories did not comply with the relevant standards.
