STUDY OF THE SURFACE INTEGRITY MICROHARDNESS OF AUSTENITIC STAINLESS STEEL AFTER TURNING

Grzegorz Krolczyk, Stanislaw Legutko, Piotr Nieslony, Maksymilian Gajek

Original scientific paper

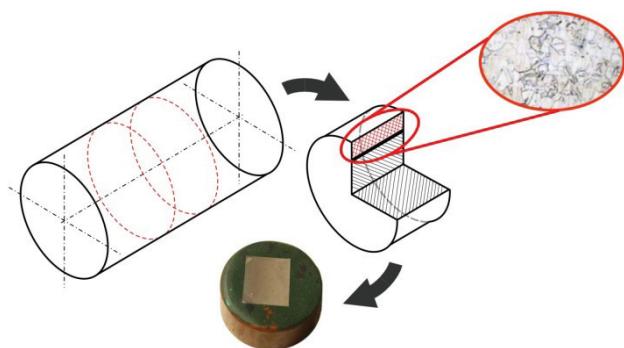
Figure 1 Method of sample preparation for microhardness testing

The Fig. 1 shows how the pieces were separated from the initial specimen for the microhardness measurements analysis (from bar material to microhardness sample). The measurements of microhardness have been performed into the depth of material along a straight line perpendicular to the machined surface (radially). In the testing schedule, it was assumed that microhardness would be measured down to the depth for which hardness comparable to that of the core was obtained. The first point of microhardness measurement was located at the distance of up to 20 µm from the machined surface, depending on the profile hump or caving. The second measurement was performed at the depth of 40 µm, the successive ones were performed at 20 µm intervals till the hardness of the core was obtained. The microhardness measurements were effected by MHV-2000. The load of an intender was

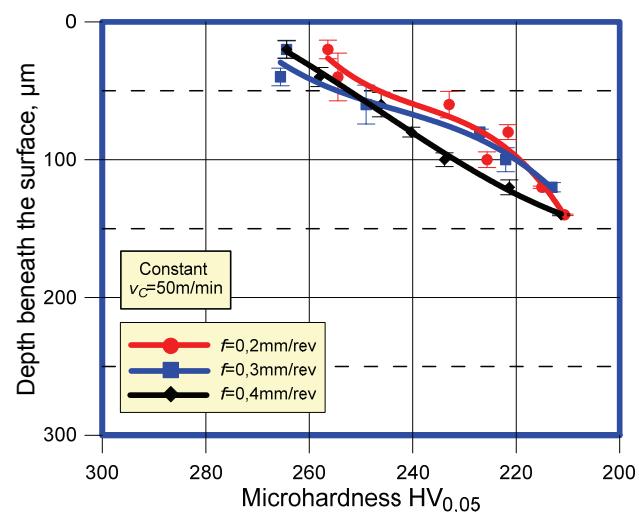
Figure 2 Influence of the feed on the microhardness of surface layer after turning austenitic stainless steel ($v_C = 50$ m/min, $a_p = 1$ mm, dry cutting)

Fig. 2 presents the influence of feed on SI microhardness for constant speeds and depths of cut ($v_C = 50$ m/min, $a_p = 1$ mm). The biggest values of microhardness were obtained for the feed $f = 0,3$ and $0,4$ mm/rev, the smallest ones for $f = 0,2$ mm/rev. The microhardness values fluctuate within the range from 250 to 270 HV_{0,05}. The value of the hardening depth for constants $v_C = 50$ m/min and $a_p = 1$ mm for the analysed feeds is 140 µm.

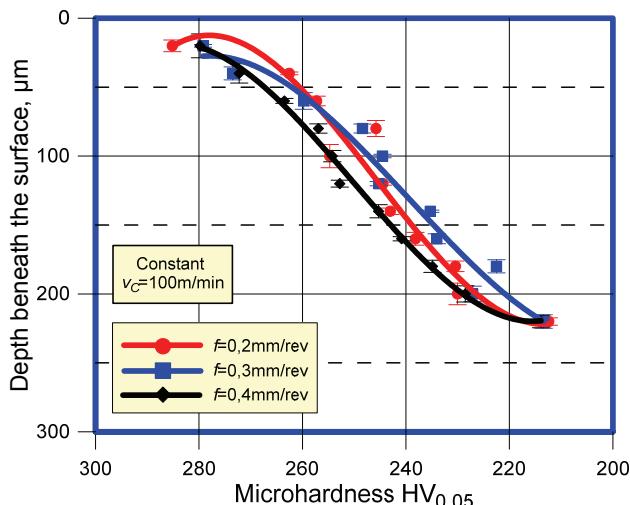
Another analysed case presented in Fig. 3 concerns the measurements of SI microhardness for variable feed and constants $v_C = 100$ m/min and $a_p = 1$ mm, analogously to the previously analysed cases for machining without the use of a cooling and lubricating substance. For the discussed feeds within the range from 0,2 to 0,4 mm/rev no significant changes in SI microhardness were observed, that is the depth of hardening for all the studied feed values was 220 µm. The initial measured value of

microhardness situated under the machined surface of the studied austenitic steel is within the range from 270 to 290 HV_{0,05}. For the analyzed value of feed we can observe a monotonic and moderate drop of the value of SI microhardness. Moreover, the results of the presented experiments characterize small fluctuations of changes, which is proven by the standard deviation values. In the analyzed case, we can observe the lack of an influence of feed on SI microhardness. There is no influence on the depth of hardening of the biggest value of microhardness HV_{0,05}.

Figure 3 Influence of the feed on the microhardness of surface layer after turning austenitic stainless steel ($v_C = 100$ m/min, $a_p = 1$ mm, dry cutting)

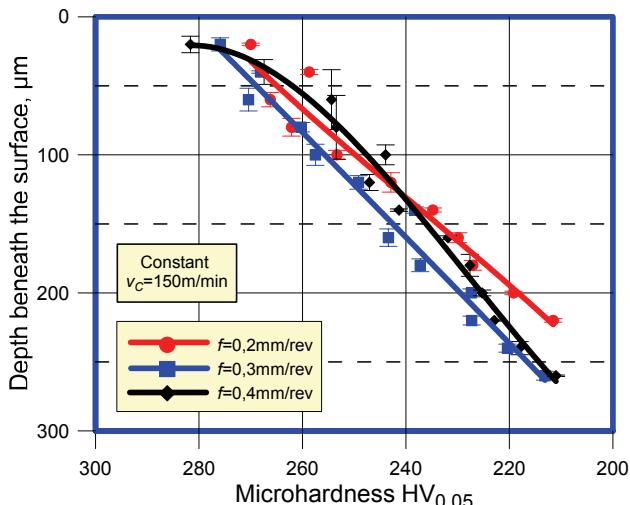
Figure 4 Influence of the feed on the microhardness of surface layer after turning austenitic stainless steel ($v_C = 150$ m/min, $a_p = 1$ mm, dry cutting)

The other analyzed case illustrated in Fig. 4 concerns the measurements of SI microhardness for variable feed and constants $v_C = 150$ m/min and $a_p = 1$ mm. For the biggest studied speed of machining, the microhardness values do not basically differ in the angle of the drop of values of microhardness HV_{0,05} and the depth of hardening shapes on the similar level as for the value $v_C = 100$ m/min, namely at the level of 220–260 μm. The average value of the biggest microhardness fluctuates as for $v_C = 100$ m/min within the range from 270 to 290 HV_{0,05}.

The findings of the research into the influence of the machining speed on the microhardness of the studied austenitic steel surface layer are presented in Fig. 5. Turning took place with the use of an edge of cemented carbide covered with a coating with an intermediate ceramic layer, for the feed $f = 0.2$ mm/rev and the constant depth of cut $a_p = 1$ mm; dry machining. The results are presented in the form of graphs, as the arithmetic mean of three measurements of microhardness with standard deviation. The biggest values of microhardness were obtained for the speed $v_C = 100$ m/min. They were obtained for the layer closest to the machined surface, namely at the depth of up to 20 μm. In this case, microhardness was over 280 HV_{0,05}. For the speed of machining 150 m/min, the microhardness obtained in this area was by 15 % smaller on average, whereas for $v_C = 50$ m/min, the observed microhardness was smaller by 30 %. Alongside departing from the surface, the SI microhardness decreases, in the analyzed case reaching the hardness of the core at the depth of about 140 μm for $v_C = 50$ m/min and 220 μm for $v_C = 100$ and 150 m/min. In Fig. 4, we can observe a monotonic and smooth decrease in the SI microhardness values for

$v_C = 150$ m/min, whereas the microhardness for the remaining analysed speeds of machining ($v_C = 50$ and 100 m/min) is characterized by a sharp angle of the drop of values to the depth of 60 µm. The reason for that may be a non-uniform deformation of the material, and thus the strengthening of austenite in the subsurface layer.

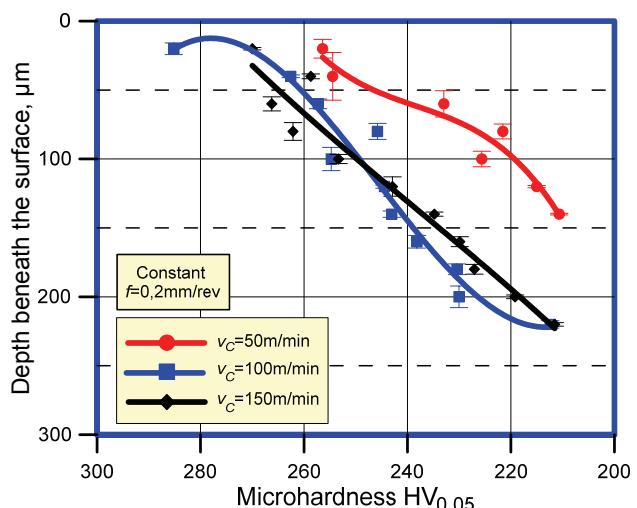
Figure 5 Influence of the cutting speed on the microhardness of surface layer after turning austenitic stainless steel ($f = 0.2$ mm/rev, $a_p = 1$ mm, dry cutting)

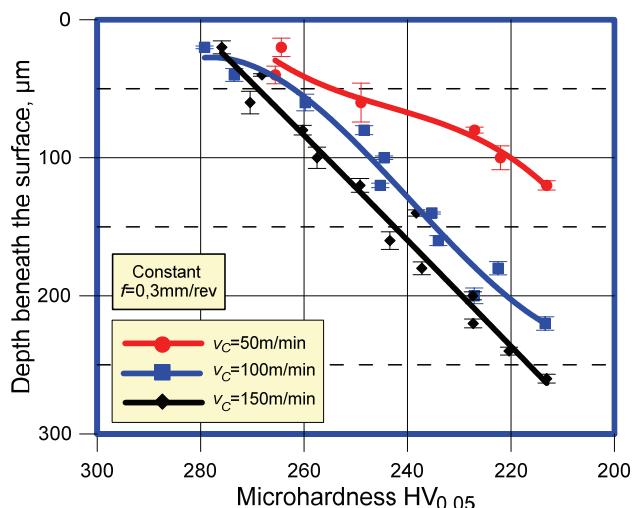
Figure 6 Influence of the cutting speed on the microhardness of surface layer after turning austenitic stainless steel ($f = 0.3$ mm/rev, $a_p = 1$ mm, dry cutting)

Fig. 6 presents the results of the measurements of SI microhardness as a function of machining speed after turning with the edge MM 2025, for the feed $f = 0,3$ mm/rev and the constant depth of cut $a_p = 1$ mm, also for the machining without the use of a cooling and lubricating substance. The biggest values of microhardness were obtained for the speed $v_C = 100$ and 150 m/min – at the level of 275 HV_{0,05}, whereas SI microhardness for a smaller speed of machining shapes at the level of about 265 HV_{0,05}. Alongside an increase in the speed of machining, microhardness after turning steel 1.4541 for the feed $f = 0,3$ mm/rev goes up, reaching hardness of the core at the depth of 120 µm for $v_C = 50$ m/min, 220 µm for $v_C = 100$ m/min and 260 µm for $v_C = 150$ m/min. For the speed of machining $v_C = 100$ and 150 m/min, we can observe a monotonic decrease in the value of SI microhardness, whereas in case of the speed of machining $v_C = 50$ m/min, there are considerable fluctuations of changes in the values and their sharp drop. Bigger depth of hardening for an increase in the speed of machining is probably caused by a higher temperature in the machining process. Alongside an increase in the machining speed a bigger amount of heat is generated, and the heat penetrates the machined material deeper.

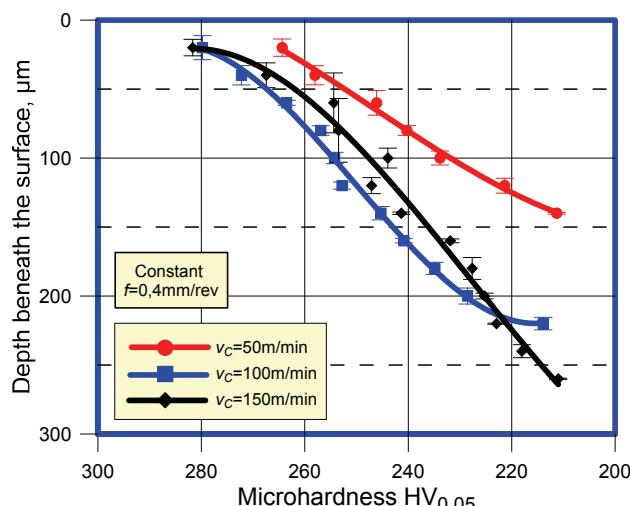
Figure 7 Influence of the cutting speed on the microhardness of surface layer after turning austenitic stainless steel ($f = 0,4$ mm/rev, $a_p = 1$ mm, dry cutting)

Last analyzed case illustrated in Fig. 7 concerns the results of the SI microhardness measurements for the variable speed of machining and constants $f = 0,4$ mm/rev and $a_p = 1$ mm. For the biggest studied feed, the depth of hardening shapes at the level of 140 ÷ 260 µm, namely the range of the depth of hardening shapes in a similar way like for the average values of the analysed feeds. The biggest average values of microhardness were obtained for the speed $v_C = 100$ and 150 m/min and they were equal to 280 HV_{0,05}. On the other hand, the smallest values of microhardness 265 HV_{0,05} were obtained for the speed of machining $v_C = 50$ m/min. For the studied speeds

of machining we can observe a monotonic decrease in the value of SI microhardness. For the analysed values of machining speed and the biggest feed, we can observe big fluctuation of changes in the biggest values of SI microhardness within the range from the surface of the machined material to 80 µm.
