Legionella Pneumophila on board ship's freshwater systems and technological and organizational measures of prevention and suppression

Davor Pavić, Predrag Kralj, Davor Lenac

Review article
Received 1 June 2017
Accepted 21 June 2017

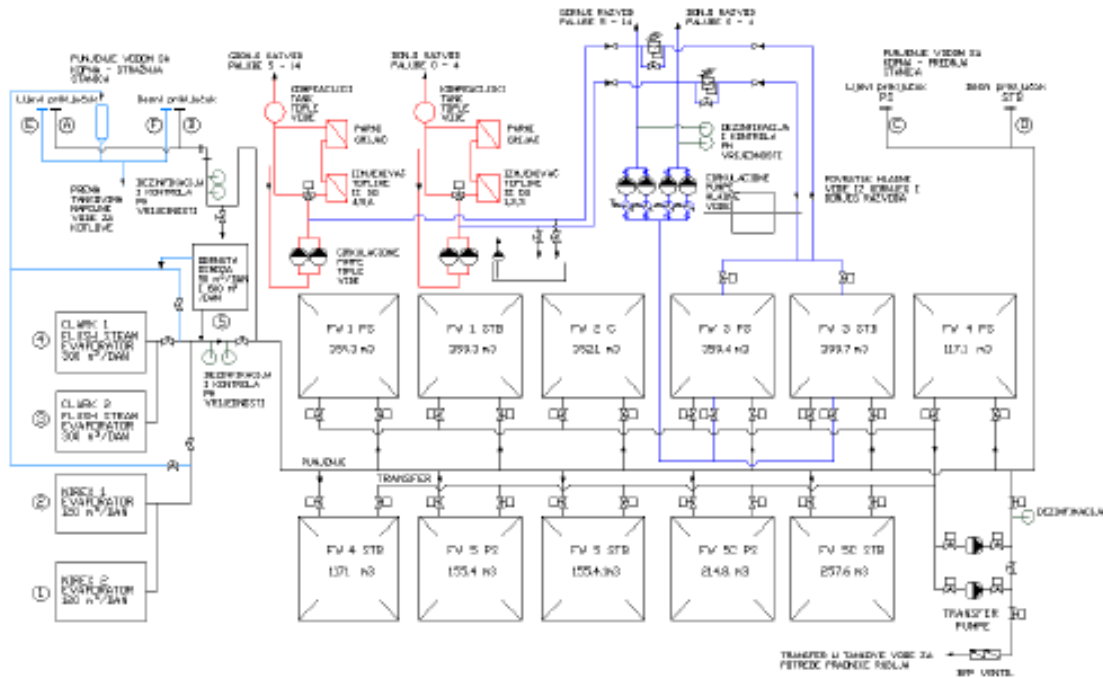
Figure 1 Bunker, Production and Distribution of Drinking water on board Passenger Ship [1]

1. potable water
2. water for decks and windows washing
3. technical water
4. water production
5. laundry
6. pool and spa

The system of bunker, production and distribution of freshwater on board passenger ships is given on Fig. 1. The freshwater production takes place in two Nirex type vacuum distillation plants (pos. 1 and 2), two Clark steam heated evaporation plants (pos. 3 and 4), and one additional RO plant 8 pos. 5). The bunker stations A, B, C and D are used for drinking water, while E and F for technical and laundry water. Connections are different so they could not be switched. There are eleven water tanks on board.

Transfer pumps are used to transfer water to the service tanks. The hot and cold water circulation pumps are also shown on Figure 1.

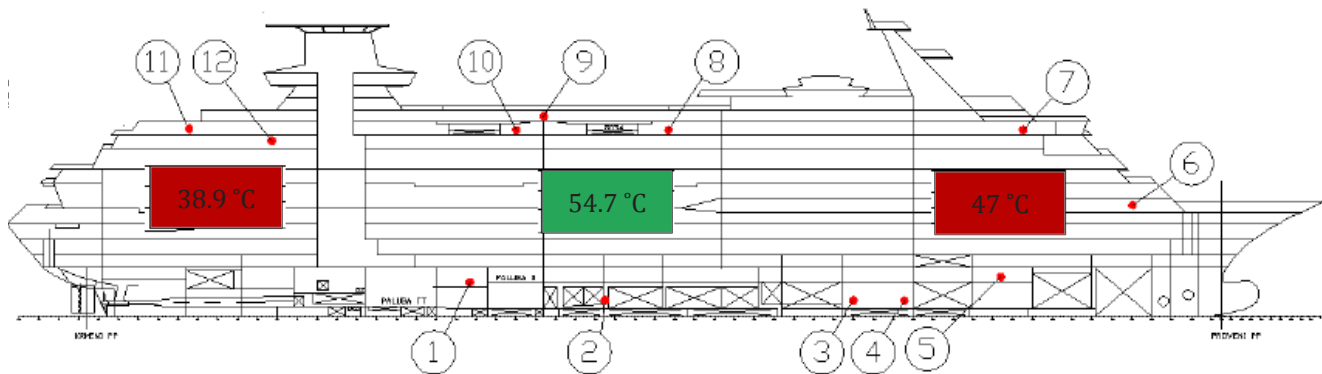
Figure 2 Cross Section of a Typical Passenger Ship [1]

The marked positions having been contaminated by legionella are as follows: 1 – bunker station for freshwater in the main diesel generator room, 2 – all hot water circulation pumps, 3 – all cold water distribution pumps, 4 – technical hot water, 5 – ships hospital on deck 1, 6 – hot water piping in some passenger cabins, 7 – hot and cold water in some passenger cabins, 8 – hot and cold water booster pumps, 9 – spa tubs, 10 – circulation, heating and filtering system for spa tubs, 11 – hot and cold water on deck 9 astern, 12 – hot water for the bar on deck 8.

After legionella bacteria have been found in the ship's water piping by sampling, some measures could be done. In Figure 2, the ship's cross section, with points to be contaminated and average temperatures in the piping that have been measured, are shown.

Figure 2 also shows possible temperature differences in parts of the ship. Generally speaking, the parts of the system closer to the circulation pumps should not be a problem, while the parts further apart from those pumps could be.
