Common failures of ship propulsion shafts

Goran Vizentin, Goran Vukelić, Mateo Srok

University of Rijeka, Faculty of Maritime Studies Rijeka, Studentska 2, 51000 Rijeka, Croatia, e-mail: vizentin@pfri.hr

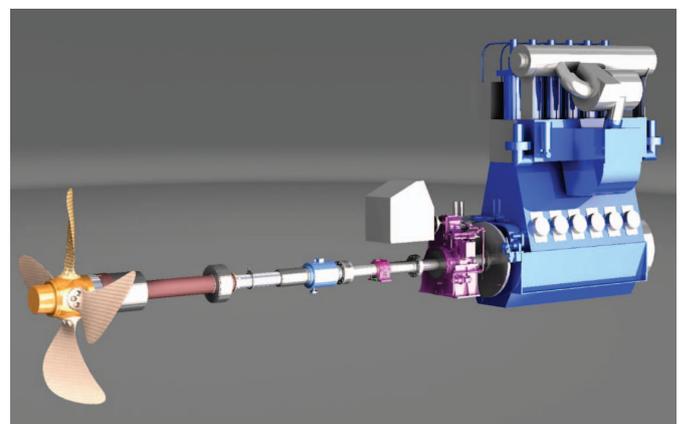
Figure 1 Typical Ship Propulsion System Elements Rendering

The propulsion system has a pivotal role on board ships. A typical marine propulsion system is comprised of the following main parts: main engine, driving device, marine shaft and propeller as shown in Figure 1. As far as fatigue is concerned, the main engine is a complex unit for itself. It represents a vibrations source (impulse operation) for the entire ship and the propulsion system as well. Here, the propulsion shaft will be discussed more in detail.

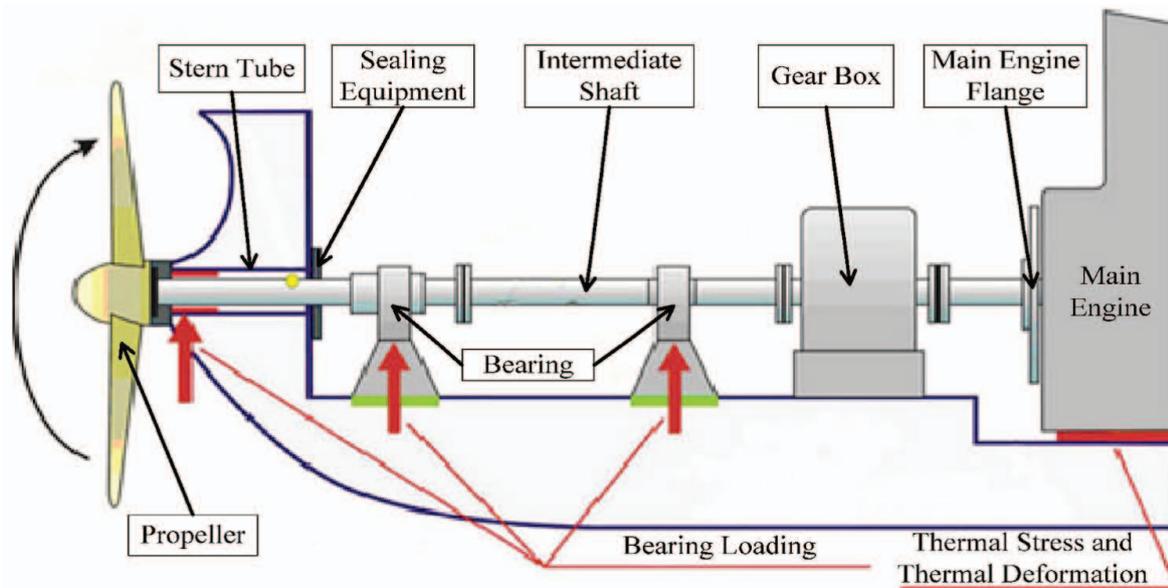
Figure 2 Propulsion System Elements and Loads Schematics [1]

The propulsion shaft is subjected to various types of loading during operation, namely torque moment, bending moment, axial thrust force and transversal loads (gravitational and centrifugal forces). The operating environment of the propulsion system is characterized by significant changes in temperatures and humidity, aggressive atmosphere (salt and/or oil mist), long lasting interrupted operating time (several months) and variations in load amplitudes. The risk of failures of the propulsion system additionally increases with the severity of sea and weather conditions as they have a direct effect on the dynamics of the load variation. All of the above has a direct influence on fatigue behaviour and life time of the propulsion shaft.

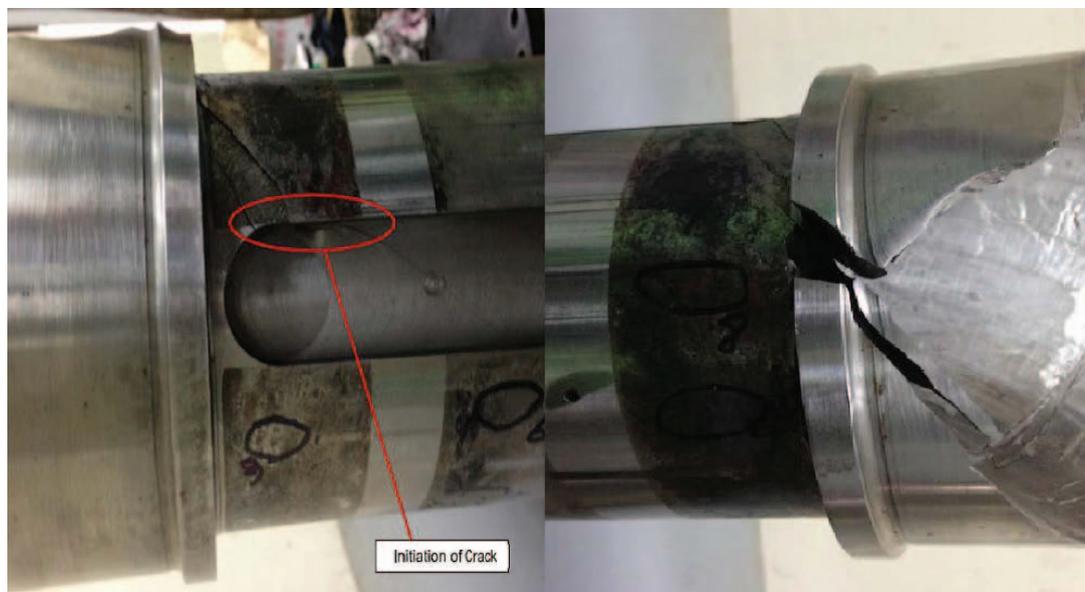
Figure 3 The Characteristic Torsional Failure Crack Shape [8]

The geometry of the ends of keyways represents a stress concentration factor in the cases of torque transmission through shaft keys for dynamic vibrational loads. Faulty machining of shaft key elements (key groove, keyway and key) geometry, inadequate run out radii or material imperfection can be root causes of torsional fatigue failure in shaft keys. The characteristic torsional failure indicator is the crack pattern that initiates at the end of the keyway and propagates in a 45° rotational direction in a helical shape, shown in Figure 3.

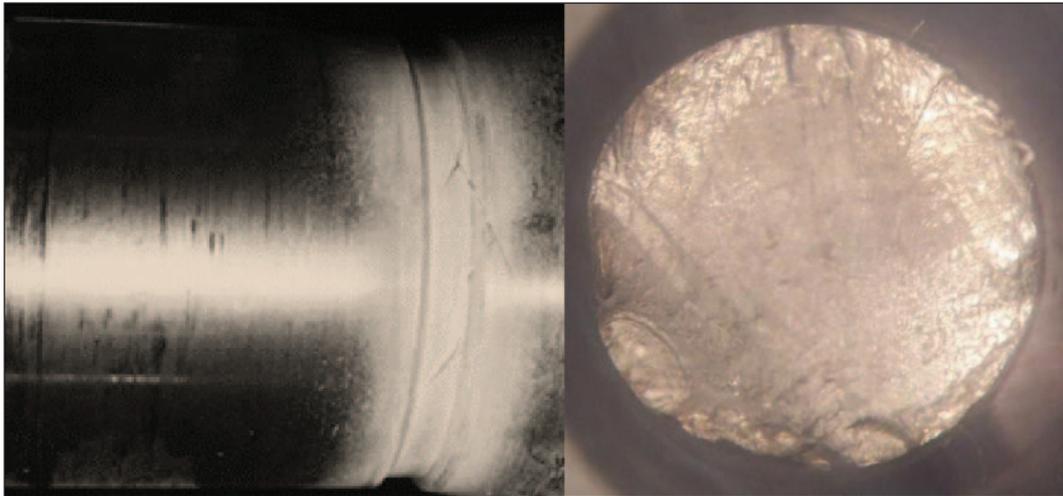
Figure 4 Shaft Fillet Failure Crack Shape [10]

studies of fractures initiated at this elements [10], [11] show fatigue due to cyclic torsional-bending load, with a crack that originates in multiple points on fillet shoulders on the shaft, gradually reducing the load bearing area of the shaft as it grows, and finally resulting in a sudden failure during overload as shown in Figure 4. The analysis for this case study has been comprised of chemical composition analysis, micro-structural characterization, fractography, hardness measurements, and finite element simulation.

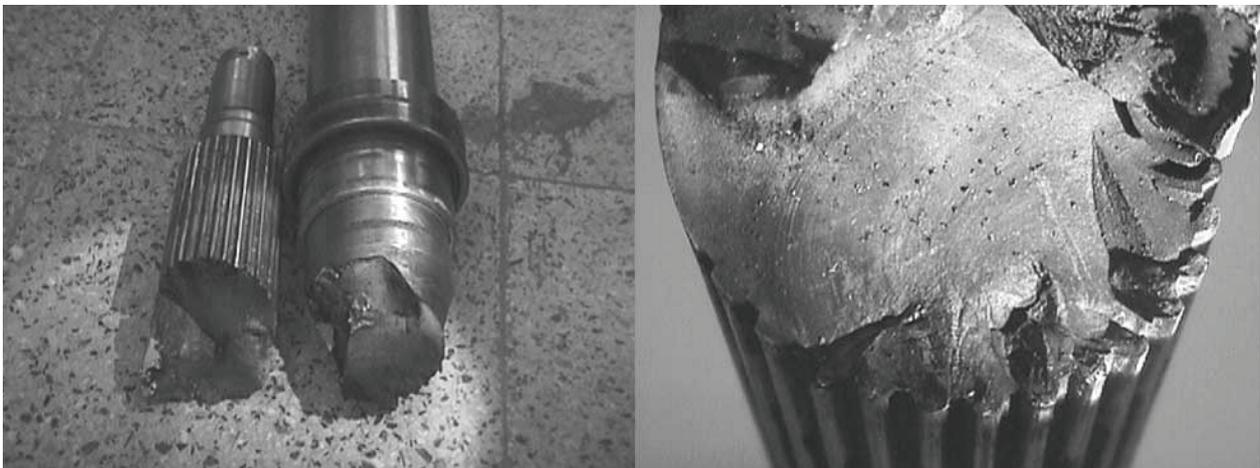
Figure 5 The Characteristic Torsion Failure Crack Propagation Shape (45° angle) [10]

The alternatives to shaft key joints are spline joints which are press fitted to other shaft elements. The analysis of spline joint failure [12] has shown that the press fitting of the joining elements can cause surface deformation which in turn causes surface cracks formation. Cracks usually start on the spline teeth at the shaft junction zone, Figure 5. Torsion fatigue caused by fluctu-

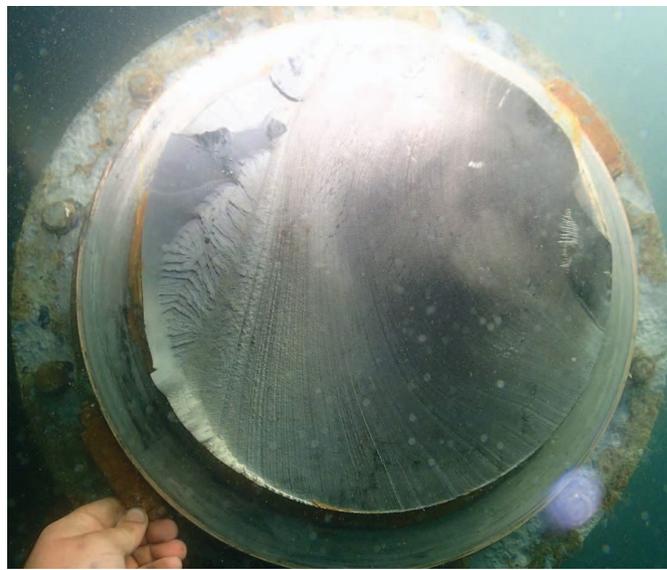
Figure 7 Uniaxial Fatigue Failure Crack Shape [15]

Abnormal performance of the propeller by way of one non-performing malformed blade can generate a uniaxial force which fluctuates once per rotation in a consistent transverse direction across the shaft. The fluctuating force generates a couple which can cause fatigue failure of the propeller hub [15]. Uniaxial type of failure is characterized by a fatigue fracture with a single origination point that progresses across the shaft from the side where the force is being applied and results in the final overload failure occurring on the opposite side from the fluctuating force.
