# PECULIARITIES OF THE STRUCTURE, ITS DEFORMATION AND DESTRUCTION OF CONDENSED Cu-Mo-Zr-Y COMPOSITE MATERIAL OF COMMERCIAL PURITY

The peculiarities of the morphology and structure defects of composite material in the Cu-Mo-Zr-Y system produced from commercially pure raw materials using method of electron-beam evaporation/condensation have been studied. The features of deformation and destruction of the composite have been investigated alongside with its mechanical properties and their change under action of structure defects.

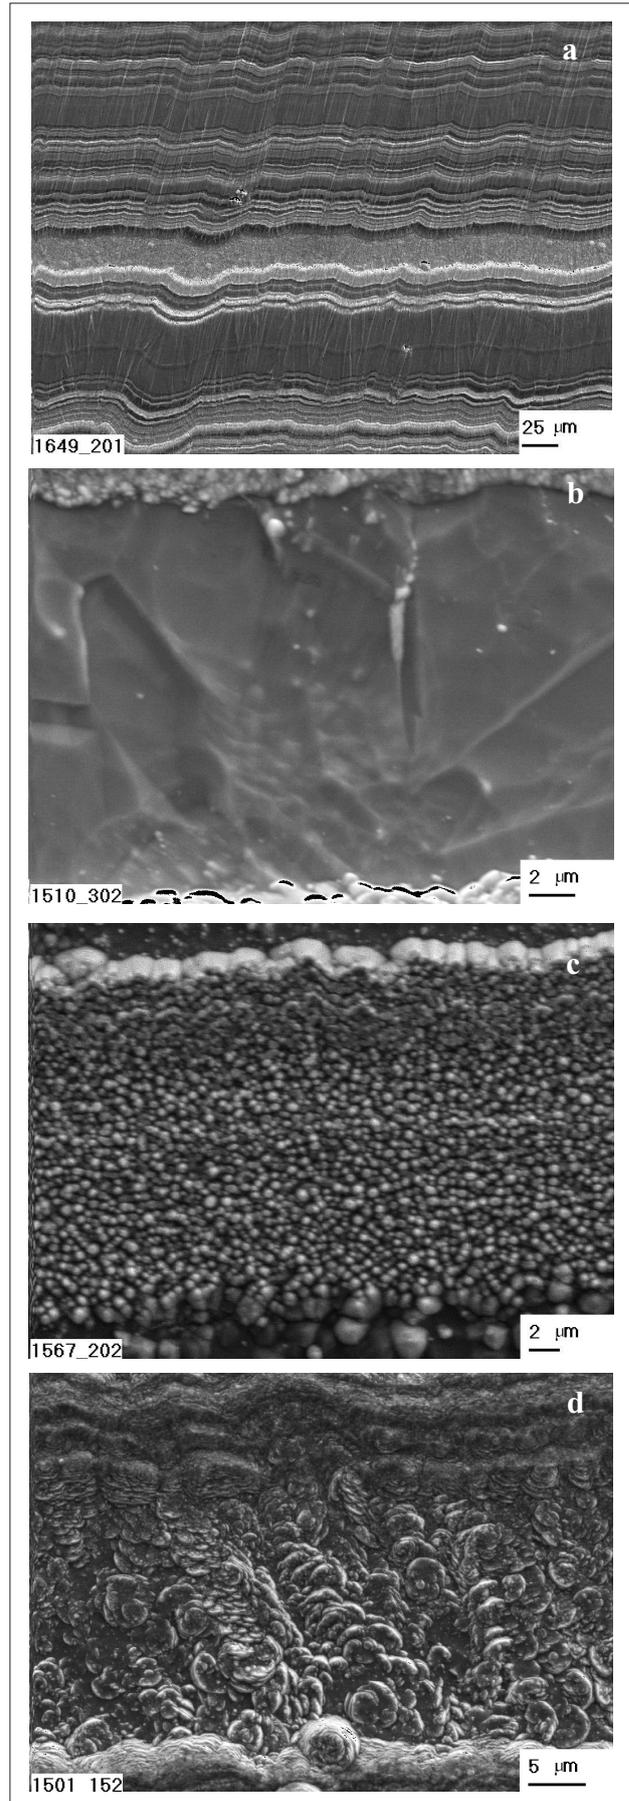
**Figure 2.** The structure of condensate layers: (a) columnlike; (b) polygonal; (c) with spherical particles; (d) with lenticular particles in the copper-based matrix.

Chemical etching of the condensate section indicates inhomogeneity of the composition and structure of the microlayers. For molybdenum-rich layers, an anisotropic (columnlike) structure is characteristic (Figure 2a), which, according to [7], is formed through joining of atoms from the volumetric diffusion field of the condensed flow to the two-dimensional islandlike layers via diffusion coales-

cence. For copper-rich layers, an isotropic structure is predominantly characteristic, which is composed either of disoriented polygonal grains (Figure 2b) or of spherical and lenticular particles dispersed in the *fcc* matrix (Figures 2c, 2d). A detailed analysis of these condensates has permitted us to conclude that the regular form of particles and the corresponding morphology of layers are related to the transformations in copper in the direction vapor – liquid. The lenticular shape of particles may result from the coalescence of solid-liquid clusters of composite material, the appearance of spherical particles at the moment of approaching the substrate and deformation of them when touching it as well as from the action of the following portions of “drop” vapor. The content of lenticular particles in the condensate layers may change (Figures 2c, 2d). By chemical composition, both lenticular and spherical particles are composites. Chemical etching of the condensate section indicates that depending on the molybdenum content, the refractory component may be present in the composite in the form of either individual grains with a diameter of much smaller than 1 μm or their conglomerates and chains. The x-ray phase analysis of the condensed composite material produced from commercially pure raw material in a medium with residual gases showed that, in addition to the main copper and molybdenum based phases, the material also contains molybdates of the CuMoO<sub>4</sub> and Cu<sub>x</sub>Mo<sub>y</sub>O<sub>z</sub> type and molybdenum carbides. These data are consistent with the results of the Auger spectral analysis of the sample fracture, which indicate the presence of carbon in the carbide form.

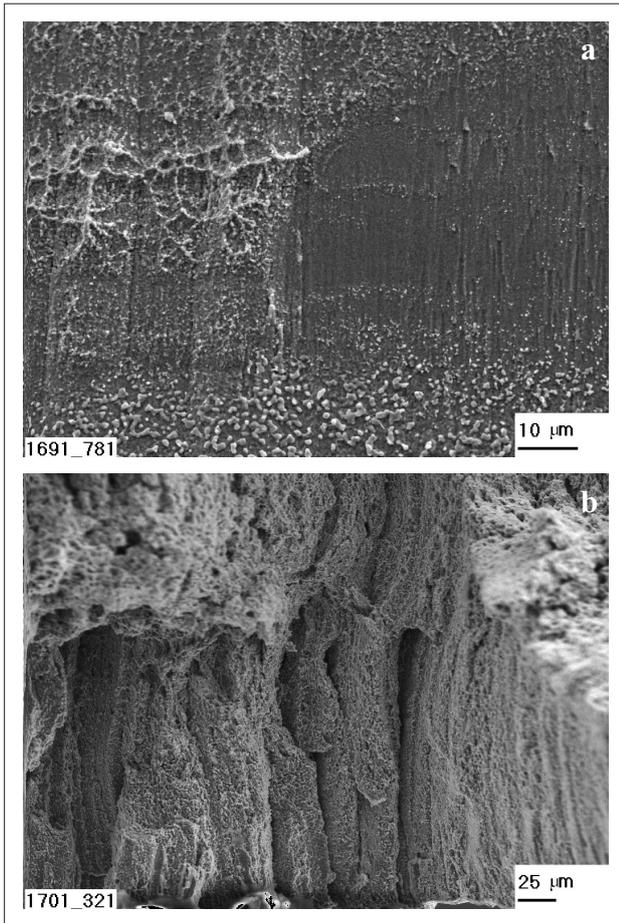
**Figure 3.** The effect of test temperature on the peculiarities of condensate destruction: (a) in the temperature range of hot brittleness; (b) over 900 K.

It was established by sight that independently of temperature and other test conditions, the destruction of samples of condensed composite material occurs by cut anticipated by plastic deformation. Even in the fracture of the sample tested in the temperature range of hot brittleness, ductile intercrystallite break along the column boundaries is observed (Figure 3a). With rising temperature and changing the mechanism of plastic deformation, the plasticity of the column structure grows accompanied during destruction by enlargement of holes formed in the presence of dispersed particles of refractory filler [11] as well as by splitting of columns and deformation of their fibers (Figure 3b).
