# Preventing aquaplaning phenomenon through technical solutions

Professional paper

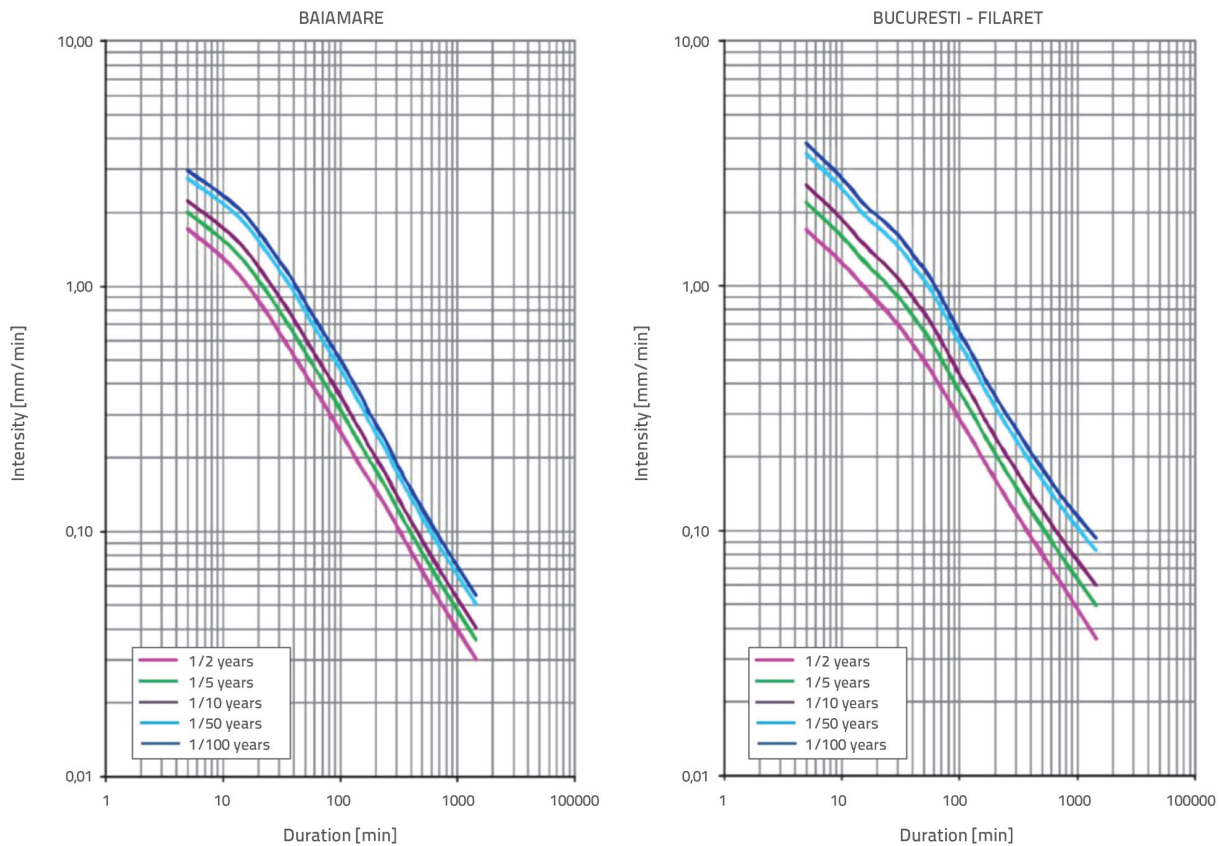
Figure 2. Intensity – duration – frequency curves based on data extracted from rainfall graphs [7]

The graph given in Figure 2 shows a rainfall intensity of 1.8 mm/min, and a duration of 5 minutes for a frequency of once every two years, up to a value of almost 4 mm/min for the same 5-minute duration, for a frequency of once every 100 years [7]. According to experts [8], this precipitation not only occurs more frequently than before, but it is also more abundant, which automatically implies the need to take appropriate measures in order to improve the infrastructure and prevent the occurrence of the aquaplaning phenomenon.

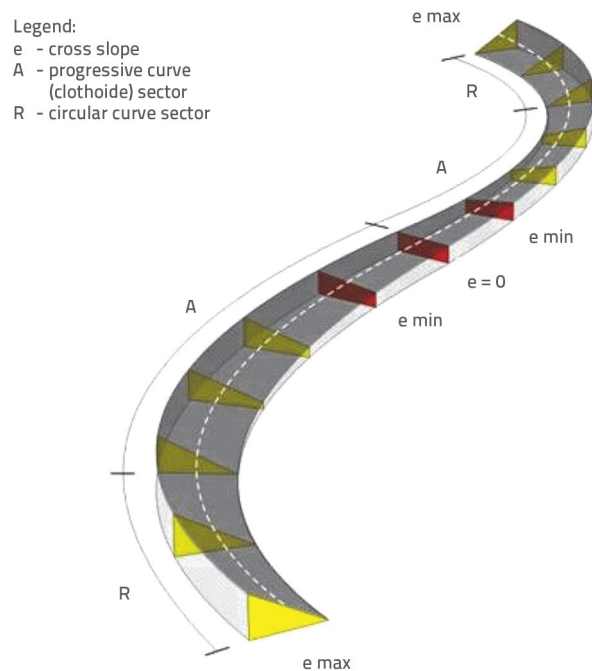
Figure 3. Three-dimensional representation of two consecutive opposite transition curves [10]

Particular elements of these transition areas are transition curves (in the road layout) and superelevation (in the cross section). Figure 3 is the three-dimensional representation of such a road section, composed of two consecutive connections

What affects the drainage capacity of this road section is not the curvature change but the change in elevation slope, especially as the passing through a null cross section is necessary, as specified in prevailing standards. This fact can also be observed in Figure 4, where the water drainage directions are represented for two cases: constant cross and longitudinal slopes, but also for the case under study, where we have a transition cross section, taking into consideration a constant longitudinal slope. Because of direction change, the length of the tracks that represents water drainage in transition sector is greater. Moreover, the water drainage slope decreases with the reduction of the cross section slope, which implies heavier drainage, resulting in accumulation of water on the carriageway.

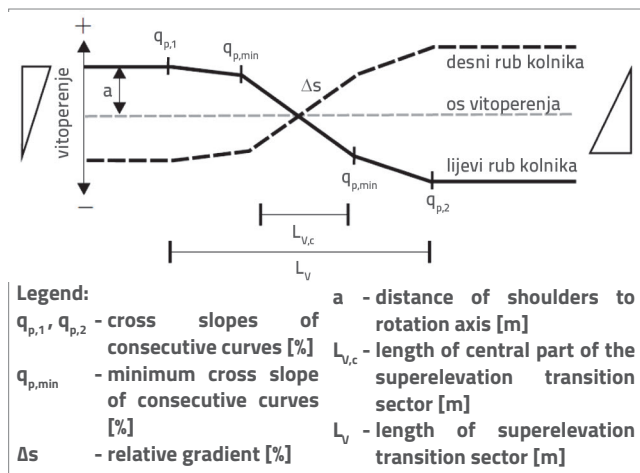
Figure 5. Projecting elevations in opposite consecutive curves [10]

To ensure a better drainage of rainwater from the carriageway, the central area of transition sector must be treated with great attention, especially due to the fact that cross slopes have values under the necessary minimum ones. Thus, this area is designed in strict conformance with current standards (Figure 5).

Because of the changes that occur due to elevation, the shoulders of the carriageway are inclined from the longitudinal slope by  $\Delta s$  (with values between 0.1a and 0.9%) [10]:

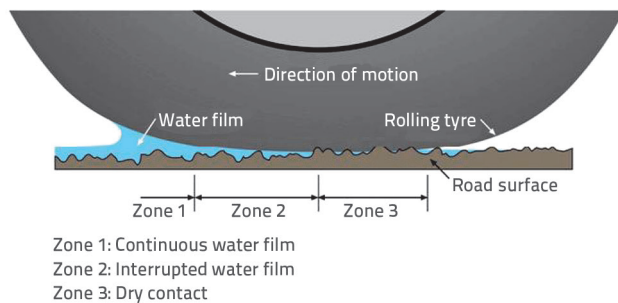
Figure 6. Water film on roadway surface at the contact between tyre and carriageway [12]

The micro texture affects mainly the asperity, as demonstrated by many laboratory studies. The research made on macro texture, which is responsible for adequate water drainage from the carriageway, is presented in this subsection. The mega texture and unevenness also influence water drainage through longitudinal slopes. Nevertheless, they will not be considered in this study. A characteristic element of the carriageway surface macro texture is a retention volume depending on texture depth. When this volume is insufficient for rain water volume, a continuous water film will form on the carriageway. At the same time, because of the asperity of the texture, a resistance to drainage is created, which can cause slow discharge and formation of areas with a larger depth of water film (Figure 6).

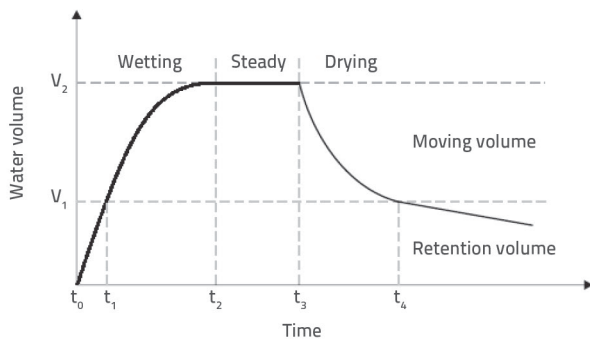
Figure 7. Graph showing drainage of water from pavement over time [10]

The water flow that discharges from the carriageway during and after a rain episode is an unstable and time dependant process. Figure 7 shows the profile of water drainage from the carriageway as related to time, and involving three stages: moistening, stable flow, and drying. If the roadway surface has asperities, the moistening and drying processes are further divided into two stages, as follows:

- $t_0 < t < t_1$  water starts to occupy the available retention volume,  $V_1$ ;

- $t_1 < t < t_2$  water volume exceeds the retention volume and starts forming a water film on the carriageway, until reaching a constant level;
- $t_2 < t < t_3$  water volume forming the film is defined as moving volume ( $V_2 - V_1$ ) and is constant;
- $t_3 < t < t_4$  water volume starts to decrease at  $t_3$ , the moment the rain stops, steadily diminishing the depth of the water slip;
- $t_4 < t$  water film disappears completely and only the water from the retention volume remains, which gradually evaporates.

Concerning aquaplaning, the second stage, i.e. constant flow, is the most dangerous period, because the depth of the water film is at its maximum. The Pavement Surface Runoff Model (PSRM) software developed by Stuttgart University allows complete simulation of the way in which water drains from the carriageway, depending on road geometry details, different types of roadway surfacing, different amenities for taking in used water, as the intensity and duration of rain episodes may vary.

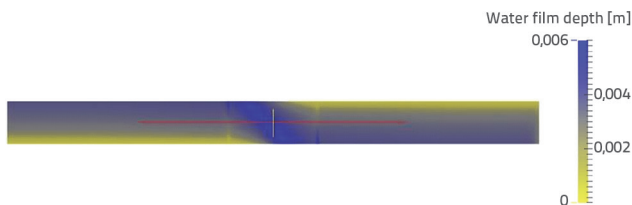
Figure 11. Water film depth on carriageway of a road sector (PSRM software)

- Road: a very coarse roadway surfacing, with an elevation slope of 3 %, vertical alignment slope of 0.5 %, conversion-elevation length of 45 meters, and carriageway width of 14 meters.

After analysis of 30 above mentioned cases, the greatest water film depths were registered as shown in Figure 11 and Figure 12.

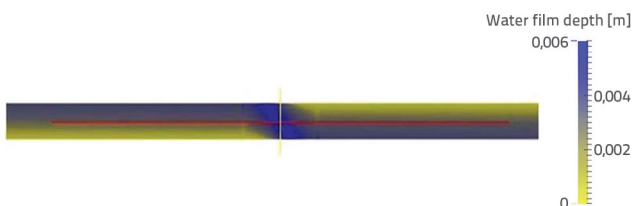
Figure 12. Water film depth on carriageway of a highway sector (PSRM software)

- Highway: a very coarse roadway surfacing, with an elevation slope of 3 %, vertical alignment slope of 0.2 %, conversion-elevation length of 140 meters, and carriageway width of 10 meters in one direction.

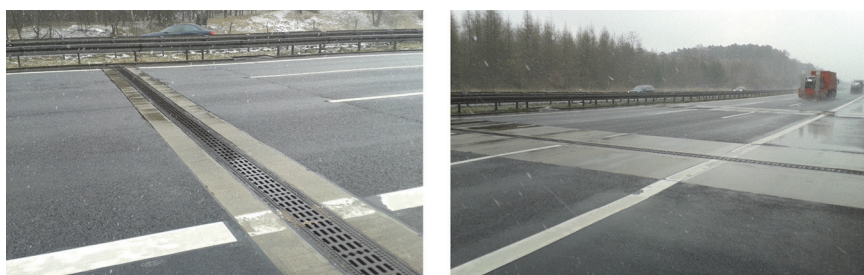
Figure 13. Examples of transverse gutters built on a highway in Germany

In the German region of Brandenburg, in a sector of the A10 Highway south of Berlin, there is a highly dangerous road segment made of concrete, which was built in the years immediately following the unification of Germany. Even though its design took into consideration weather conditions with heavy rainfall, the proposed transverse slope was not sufficient, which resulted in a high number of road accidents due to the phenomenon of aquaplaning. The only adequate method for this section involved construction of transverse gutters, made of concrete and covered with metal bars. These gutters were built across the entire width of the carriageway, including the emergency lane in the case of highways (Figure 13). The gutters are no less than 30 cm in width and several can be assembled along a sector, at a distance of minimum 5 meters between individual gutters, as shown in simulations made with specialised software, such as the Pavement Surface Runoff Model.

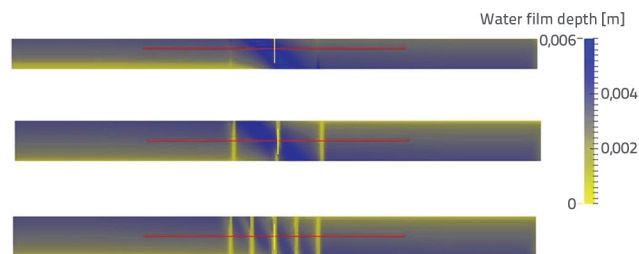
Figure 14. PSRM software simulation of the effect of transverse gutters on a road sector

As an example, the least favourable cases presented in the previous subsections were assumed, and simulations were made for 3 and 5 transverse gutters for a road sector, and 5 and 7 transverse gutters for a highway sector, as shown in the following figures (Figure 14 and Figure 15):

The use of transverse road gutters results in the decrease of water film depth from 6 mm to 4 mm, and even to 2 mm, which considerably diminishes the risk of aquaplaning. The same result is also obtained by implementing diagonal slopes in order to eliminate the profile with zero slope between two consecutive opposite slopes. Good results have been achieved in practice by both methods, the only inconvenience being the difficulty in their implementation, as special machinery and qualified personnel are required.

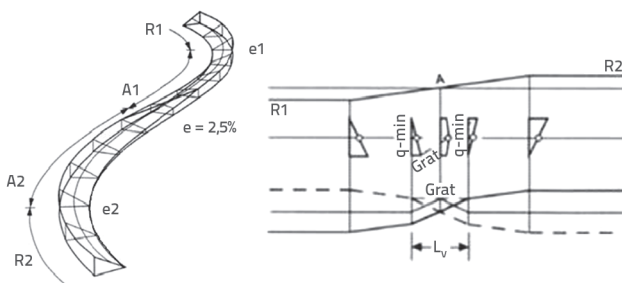
Figure 16. Example of case where diagonal slope was used [13]

Switzerland (Figure 16) use a technical solution that involves creation of a diagonal slope that does not follow upper shoulders of the converted profiles. Thus, the transverse profile of the roof type, with slopes of 2.5 %, is realized at the point where the cross section meeting the zero slope was initially found.

This method is mentioned in German standards RAS-L (FGSV 1995) and RAA (FGSV 2008), but only the latter presents the formula for calculating the length of the diagonal slope, in relation to the width of the carriageway and design speed:

$$L_v = 0,1 \cdot B \cdot V_p \quad (2)$$

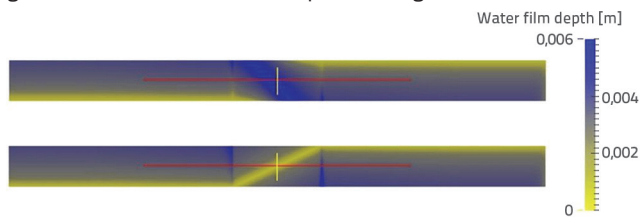
Figure 17. PSRM software simulation of the effect of diagonal slope, road sector

The least favourable cases presented in the previous subsection were taken into consideration, and two simulations were made for the road sector and highway sector, respectively, as shown in the following figures (Figure 17, Figure 18): The main disadvantage of this technical solution is the considerable difficulty involved in actual realisation of the solution. However, the results for diminishing the depth of the water film are very good, as it can be observed in previous figures.

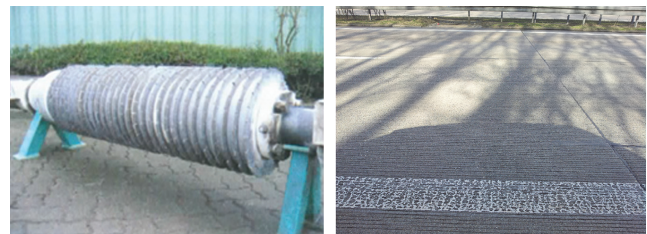
Figure 19. Grinding grooves on roadway surface

Another measure that is used to facilitate rapid water drainage from the carriageway is to groove the road surface using a special device with diamond disks. Thus, tiny longitudinal or transverse furrows are created on the cement concrete surface of the roadway, as shown in Figure 19. Their dimensions are established using the following relation:

German standards recommend maximum groove width between 2.4 mm and 2.6 mm for longitudinal grooves, because of negative impact they can have on motorcycle traffic, and between 6 mm and 10 mm for transverse grooves. The minimum depth has yet to be determined, but the recommended value is 3 mm, while the maximum depth is around 5 mm, as an additional increase in depth would imply much higher costs.

The introduction of grooves on road surface decreases the depth of the water film considerably. However, the usefulness of such grooves is reduced during winter because of the frost-defrost phenomenon. This method can therefore be considered as a temporary measure only, and should be applied solely on cement concrete roads.
