CORROSION CHALLENGES TOWARDS A SUSTAINABLE TURNING OF STAINLESS STEEL UNDER DIFFERENT COOLING METHODS

Graciela Šterpin Valić^{1*} – Dario Kvrđić² – Goran Cukor¹ – Maja Vlatković¹

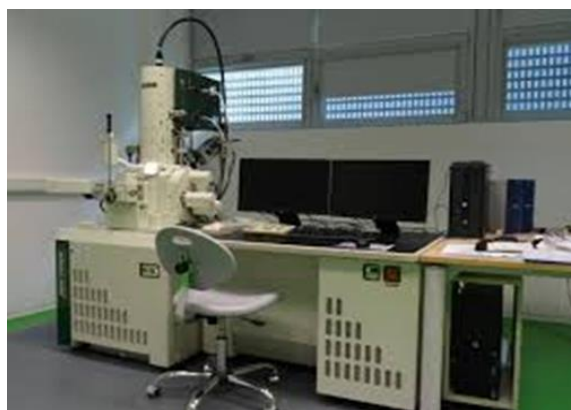
Figure 2. SEM/EDS analysis device.

Detailed morphological and compositional analysis was carried out using scanning electron microscopy (SEM) coupled with energy-dispersive spectroscopy (EDS). A JEOL JSM-7800F microscope equipped with an Oxford Instruments X-MaxN80 EDS detector was employed for these analyses, Figure 2. Surface characterization was performed both before corrosion testing (to evaluate machining-induced conditions) and after exposure (to assess localized damage and compositional changes). After corrosion, three characteristic zones were examined: (i) unaffected surface regions, (ii) pit edges, and (iii) pit bottoms, with at least three measurements taken for each zone.

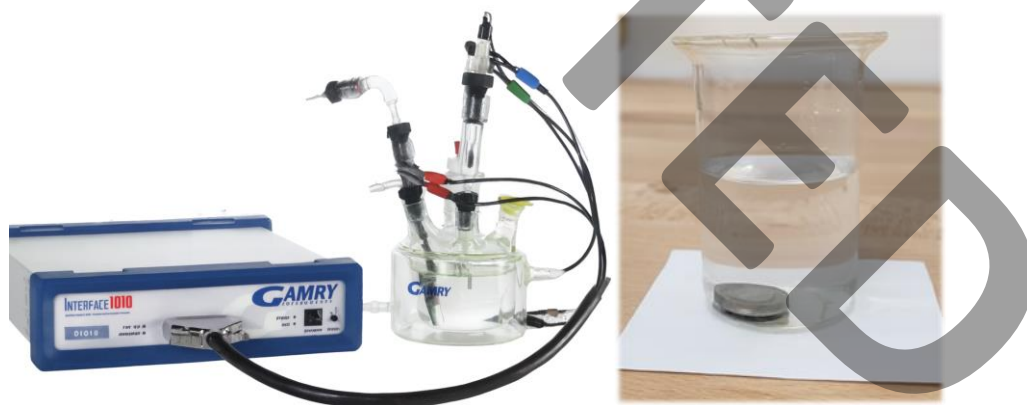
Figure 3. Electrochemical test setup with Gamry Interface 1010E potentiostat and Gravimetric setup with 316L steel samples immersed in 3.5 wt.% NaCl solution.

In parallel with electrochemical testing, immersion experiments were performed for long-term evaluation. Samples were fully immersed in a 3.5 wt.% NaCl solution at 25 ± 1 °C for a total duration of 28 days, Figure 3. At intervals of 7, 14, 21, and 28 days, the specimens were removed, cleaned to remove corrosion products, dried, and weighed using a precision balance (± 0.1 mg). Mass loss values (Δm) were used to calculate average corrosion rates.

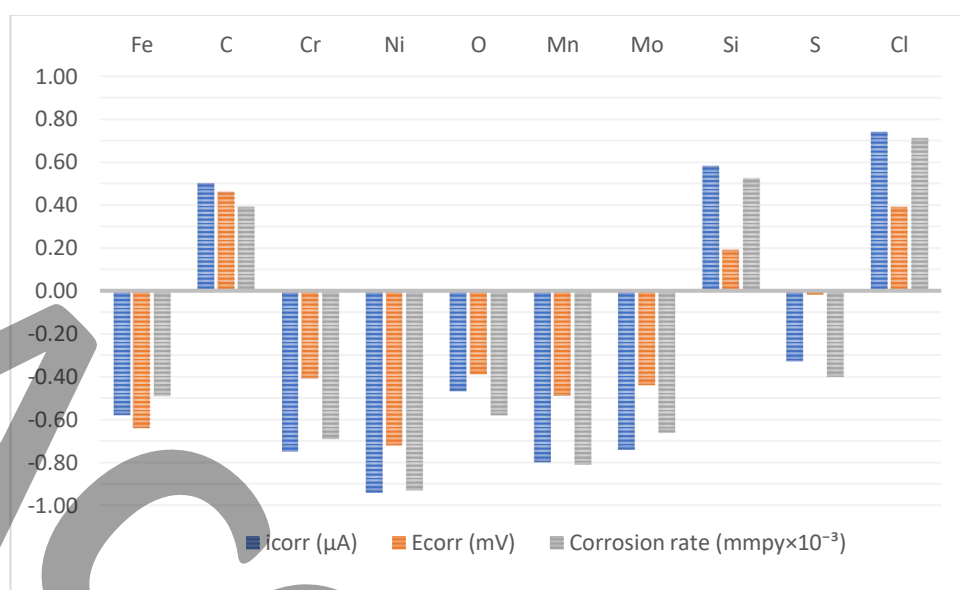
Figure 12. Bar chart of correlations between surface composition after corrosion and destructive electrochemical parameters.

Nickel exhibited the strongest negative correlations with i_{corr} ($r = -0.94$) and corrosion rate ($r = -0.93$). This confirms that Ni depletion directly destabilizes the passive film and increases reactivity, with samples containing the lowest Ni showing the most intense degradation [25].
