TESTING OF PHYSICAL AND MECHANICAL PROPERTIES OF BRICKS AND MORTAR IN HISTORIC STRUCTURES

Mirjana Bošnjak-Klečina, Silva Lozančić

Preliminary notes

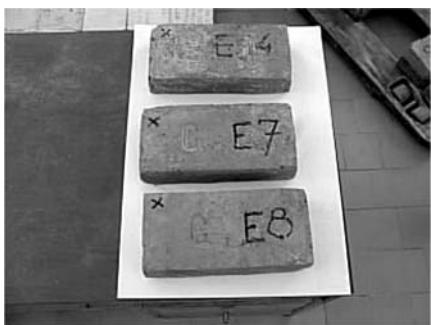
Figure 1 Tested brick samples
Slika 1. Uzorci ispitanih opeka

The testing has been carried out in accordance with the valid European standards. The samples of old bricks have been taken from three locations: St. Michael's church in Osijek, St. Philip and Jacob's church in Vukovar and Eltz's manor house in Vukovar. The bricks were made in 18th century, most likely in brickyards near the mentioned structures. The samples are shown in Fig. 1. The new brick is solid masonry unit manufactured in a modern Slavonian brickyard. Each testing has been carried out on one sample

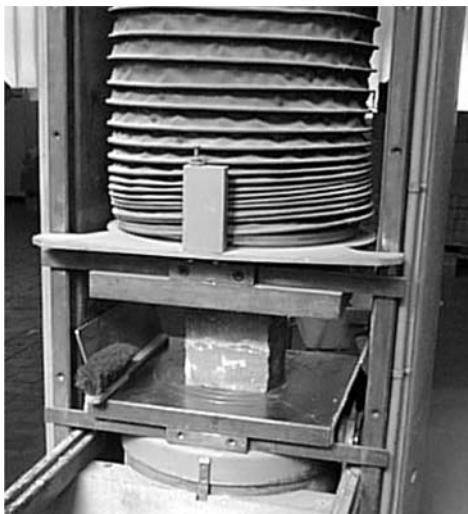
Figure 2 The brick before failure
Slika 2. Opeka prije sloma

Compressive strength. The compressive strength of brick elements has been tested by gradual increase of the compressive force up to the failure of sample, according to the procedure described in the norm [8]. The tests were performed on a sample made by joining two halves of the same brick. The test is shown in Figures 2 and 3. Results of tests are shown in Tab. 5.

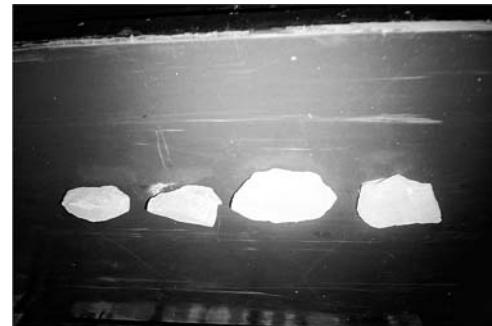
Figure 4 The samples removed from the building
Slika 4. Uzorci izvadeni iz građevine

The samples are presented in Figures 4 and 5.

The old mortar samples were taken from the 18th century structure located at the Tvrđa in Osijek, built at the same time and with the same material as the observed structures. Because of the difficulties connected with finding the right undisturbed samples the scope of investigation has been limited. The samples were obtained by removing the mortar from the existing building.

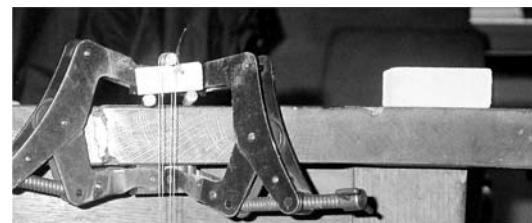
Figure 5 Samples prepared for testing
Slika 5. Uzorci pripremljeni za ispitivanje

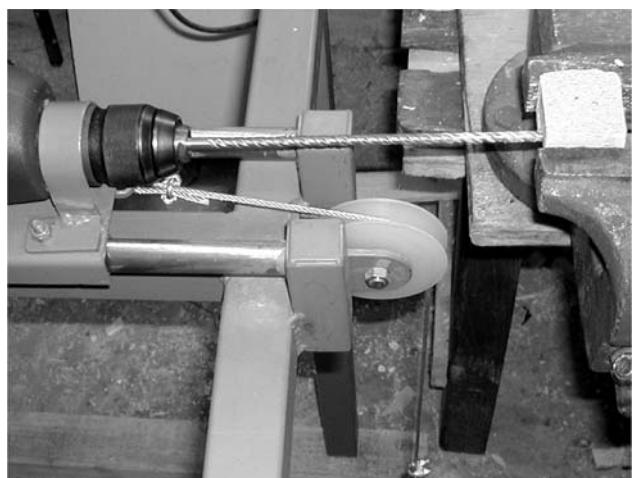
To conduct the tests, a device has been constructed according to the original idea [2] (Figures 11 and 12). The device consists of a power drill mounted along the horizontal brackets on a steel support. The test is carried by drilling through the mortar by constant drill rotation speed and force. The constant force is provided by hanging the weights of desired amount on pulley. The power drill slides along the well greased brackets (to decrease the friction at minimum). The depth of the drill's penetration within determined time is measured and so the penetration speed is obtained.

Figure 12 Mortar compressive strength testing
Slika 12. Ispitivanje tlačne čvrstoće morta
