ECHOCARDIOGRAPHIC EVALUATION OF PATIENTS WITH HEART MATE II CONTINUOUS FLOW VENTRICULAR ASSIST DEVICE

Lech Paluszkiewicz

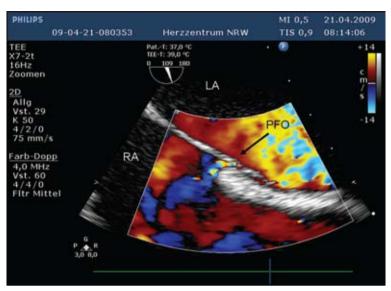
Fig. 1. 2-D and Color Doppler transesophageal echocardiographic examination. Patent Foramen Ovale with left to right shunt. LA – left atrium, RA – right atrium, PFO – Patent Foramen Ovale.

The most common shunt observed is Patent Foramen Ovale (PFO); this shunt occurs in up to 27 % of patients [4]. The methods of examination do not differ from the standard examination; however, the examination of a patient with advanced heart failure requires several remarks. First and foremost, the LV dysfunction with elevated left-side pressures will unmask left to right shunt, which can be easily recognized with color Doppler (Fig. 1). In case of an increase in the right-side pressures, left to right shunt may not be visible despite the use of echocardiographic contrast and Valsalva maneuver. The latter must be used with caution in a patient with advanced heart failure. The assessment of the continuity of the interatrial septum should be repeated after the introduction of CPB and after starting the VAD device. Significant shunts must be closed at the time of operation. The exploration of other possible sites of intracardiac shunts should not be omitted.

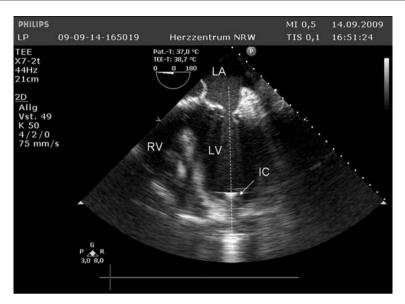
Fig. 2. 2-D transesophageal echocardiographic examination, 4 chamber view. The inflow cannula in the apex of the left ventricle. LA – left atrium, LV – left ventricle, RV – right ventricle, Arrow shows the inflow cannula – IC. Dashed line shows axis between inflow cannula and mitral valve.

The evaluation of the alignment of inflow and outflow cannulas should also be performed after chest closure. The inflow cannula should be directed toward the mitral valve and should not touch any wall (Fig. 2). The flow in the left ventricle and both cannulas can be estimated using Color Doppler and measured with both PW and CW Doppler. While assessing the inflow cannula, unidirectional and laminar flow without turbulence should be considered normal. PW measurements show a continuous pattern of flow with slight pulsatile increase in the flow velocity, synchronous with cardiac contraction (Fig. 3a, Fig. 3b). The continuous flow velocity signal from 0,6 to 1,2 m/s can be demonstrated. The maximal flow velocities of 1-2 m/s are considered normal [2,3,5]. The properly unloaded left ventricle has approximately

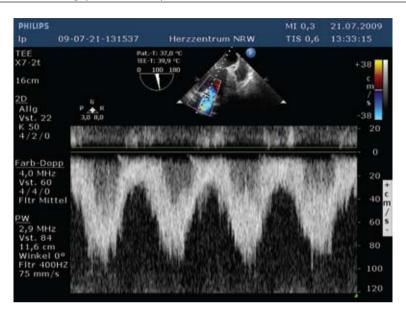
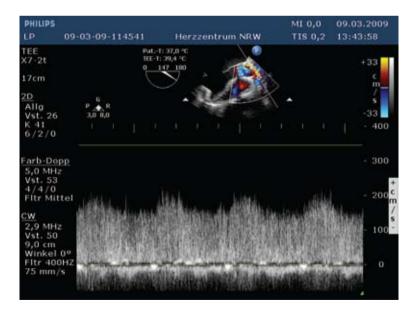
Fig. 3. PW and CW Doppler transesophageal echocardiographic examination. Flow velocity pattern across the inflow (a) and outflow cannula (b).

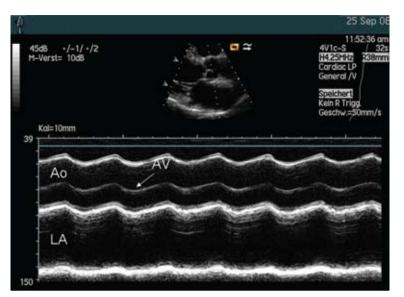
Fig. 4. M–Mode echocardiographic examination. AV remains closed both in systole and diastole. Ao – aorta ascendens, AV – aortic valve, LA – left atrium.

normal diameter, the aortic valve is permanently closed (Fig. 4) and the interventricular septum is in the neutral position. Intermittent partial aortic valve opening is acceptable and should decrease the risk of thromboembolic complications. The function of the right ventricle should be carefully monitored after VAD is started. The methods of assessing its function are similar to preoperative evaluation.

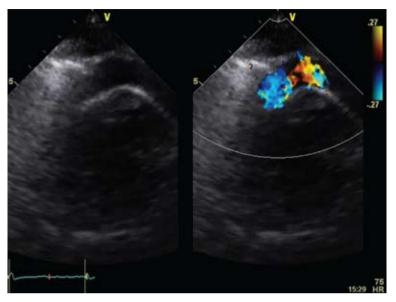
Fig. 5. 2-D and Color Doppler transthoracic echocardiographic examination, right parasternal view (second intercostal space). The outflow cannula with flow is visible.

complicated cases. In special cases, transesophageal examination is necessary. The standard TTE examination should be performed including the cannulas alignment and the flow velocity pattern. The visualisation of the outflow cannula is often possible in the second right intercostal space (Fig. 5). Since the device flow is dependent on pre and afterload, as well as on the pump speed, the actual blood pressure and pump speed should be noted.
